CASE STUDY : PHOSCRETE HC

Bridge Expansion Joint Header

Location: [Burnside Bridge, Portland OR](#)

Agency: Multnomah County DOT

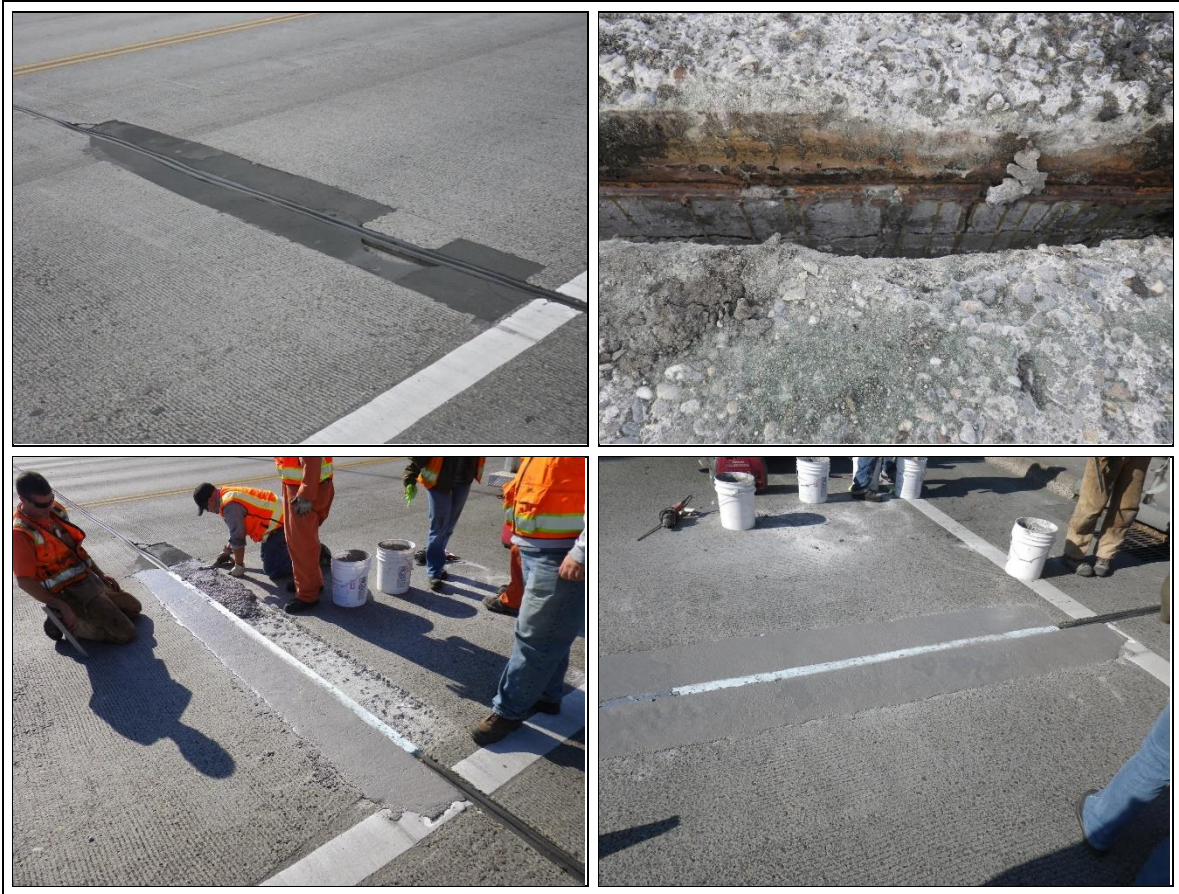
Installation Notes: Repairs were performed on both sides of an expansion joints a heavily travelled bridge in Portland. The original elastomeric header material deteriorated the joint sealant was damaged. Phoscrete was quickly installed, without need to shotblast the rusted reinforcing steel. Blueboard as used to re-establish the joint, and was easily removed after pouring both sides of the header.

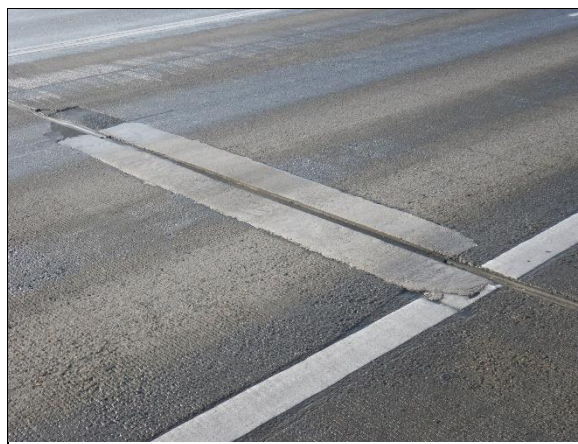
5 month inspection 12/11/2013

Reinspection Notes: Following five days of subfreezing temperatures, a five-month site reinspection showed no shrinkage, no cracking, and no delamination. Follow-up Inspection photos show the repair solidly in place after 4 years.

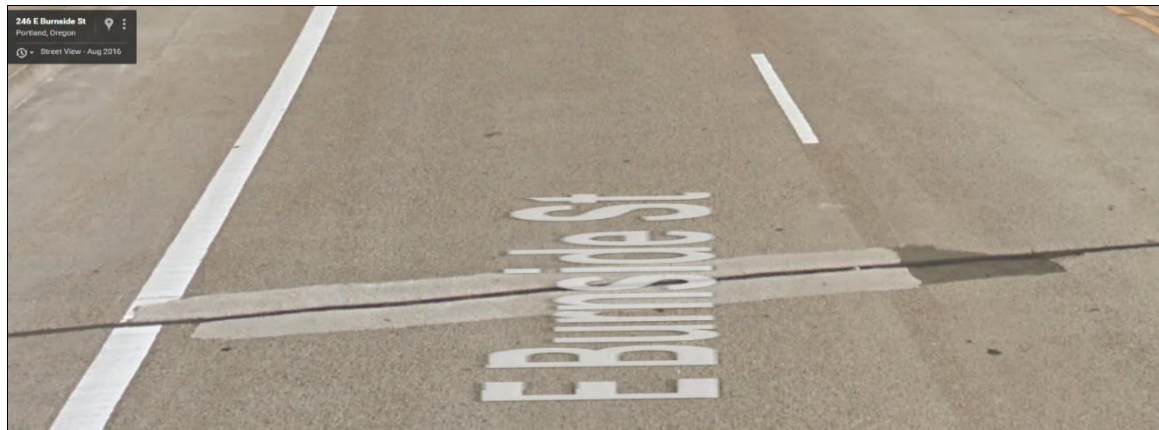
Above: 3 year inspection 8/2016 (Google Maps satellite image) Below: 4 year Inspection 3/10/2017
