CASE STUDY : PHOSCRETE HC

Bridge Joint Header Installation

Location: [Clyde NC](#)

Agency: NCDOT (GLF Construction Corporation)

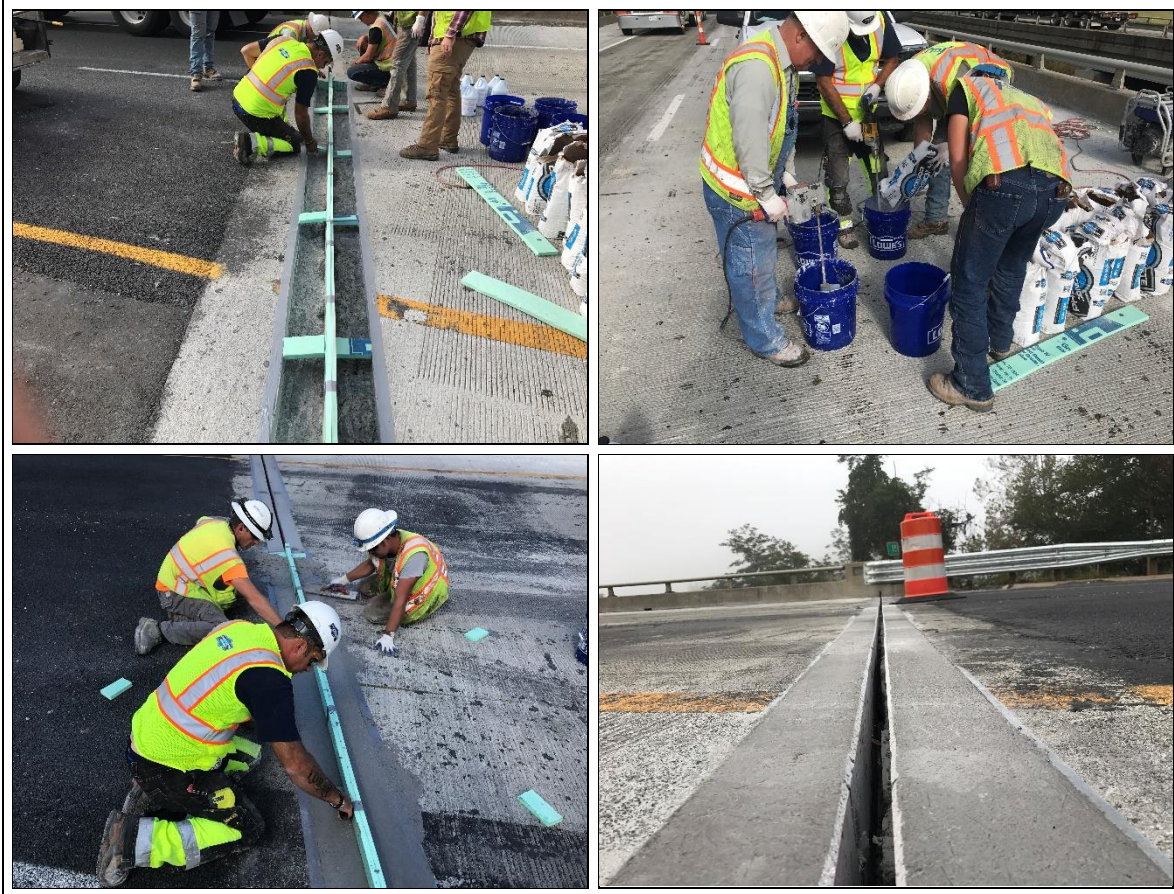
Inspection Notes: Original installation was performed using Phoscrete HC on 4/28/2017 and spalling was reported by NCDOT in August 29, 2017. Subsequent inspection determined that the material was installed in hot temperatures by a crew using Phoscrete for the first time, and they did not chill the activator per Phoscrete's intallation guidelines. Hammer testing revealed several points of delamination, an indication that the fast-setting material was setting up prior to placement.

Because of the close attention paid to this repair, the header was inspected on November 20, 2017, December 6, 2017, and February 18, 2018. Hairline cracks were observed in the header in November. This is normal and likely attributed to impact/load stress from heavy truck traffic. No additional hairline cracks were observed in subsequent inspections, and the size did not change. Hammer testing indicates no delamination across the joint. no spalling was observed.

Installation Notes: Full span of two deteriorated joint headers on I-40 bridge over Hyder Mountain Road was saw cut, demolished and replaced with Phoscrete HC over two days with traffic control switched as soon as header was traffic ready (one hour after initial pour). Closed cell foam joint seal was installed the next day.

Cameron Cochran, NCDOT Western Regional Bridge Construction Engineer and the contractor GLF agreed to demolish and re-install the header using Phoscrete HC with Phoscrete's installation manager, Don Visel on-site for training and support.
