# CASE STUDY : PHOSCRETE F1-HC

## Bridge Deck Patch

**Location:** [Vincent Thomas Bridge, San Pedro, CA](#)      **Ambient Temperature:** [68°F](#)

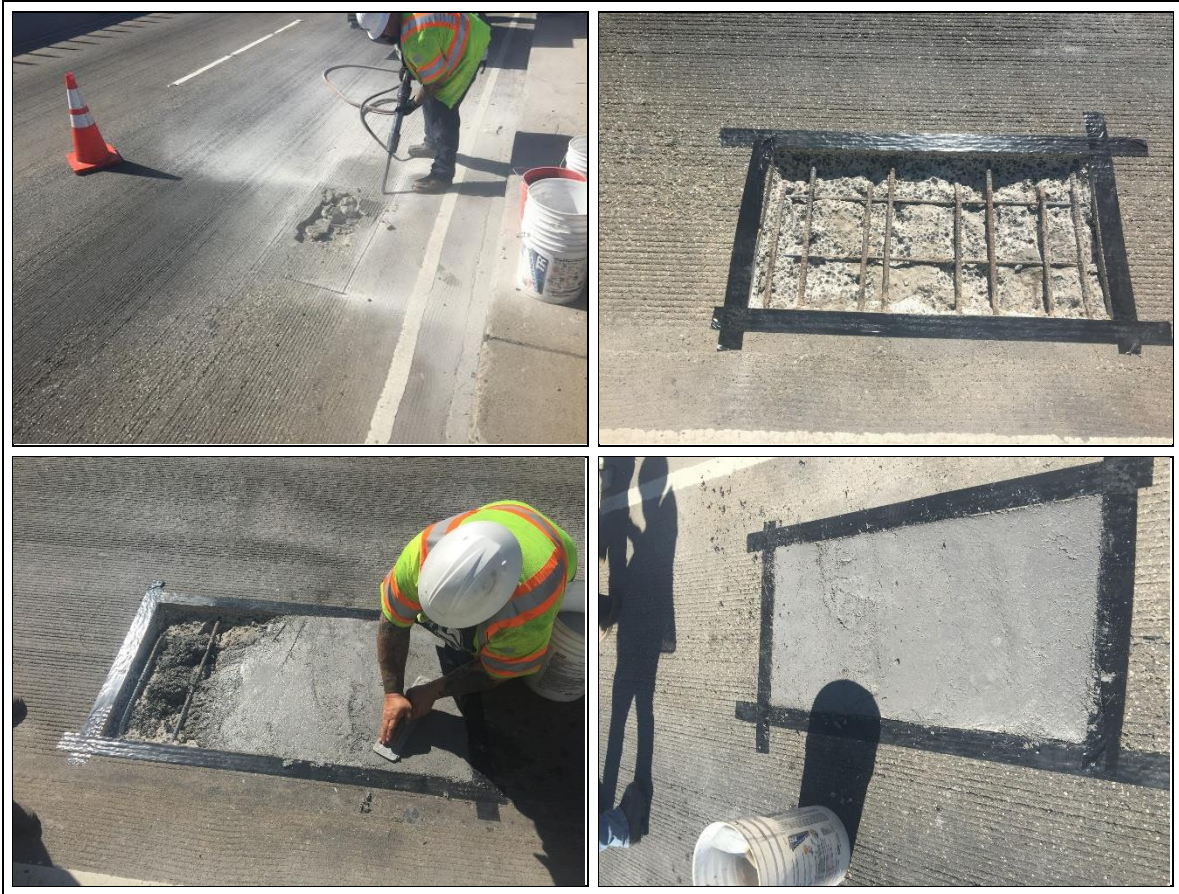
**Installation Notes:** Deck patching was performed on the westbound slow lane of this long suspension bridge that routes cargo to the Port. Many different patching materials have been used on this bridge, but heavy traffic and extreme fluttering cause other materials to debond, crack and fail, often in weeks. Phoscrete was quickly installed. The repair was traffic-ready in one hour, and the patch remains solid in place today.
