## CASE STUDY : PHOSCRETE F1-HC

### Bridge Joint Header Repair

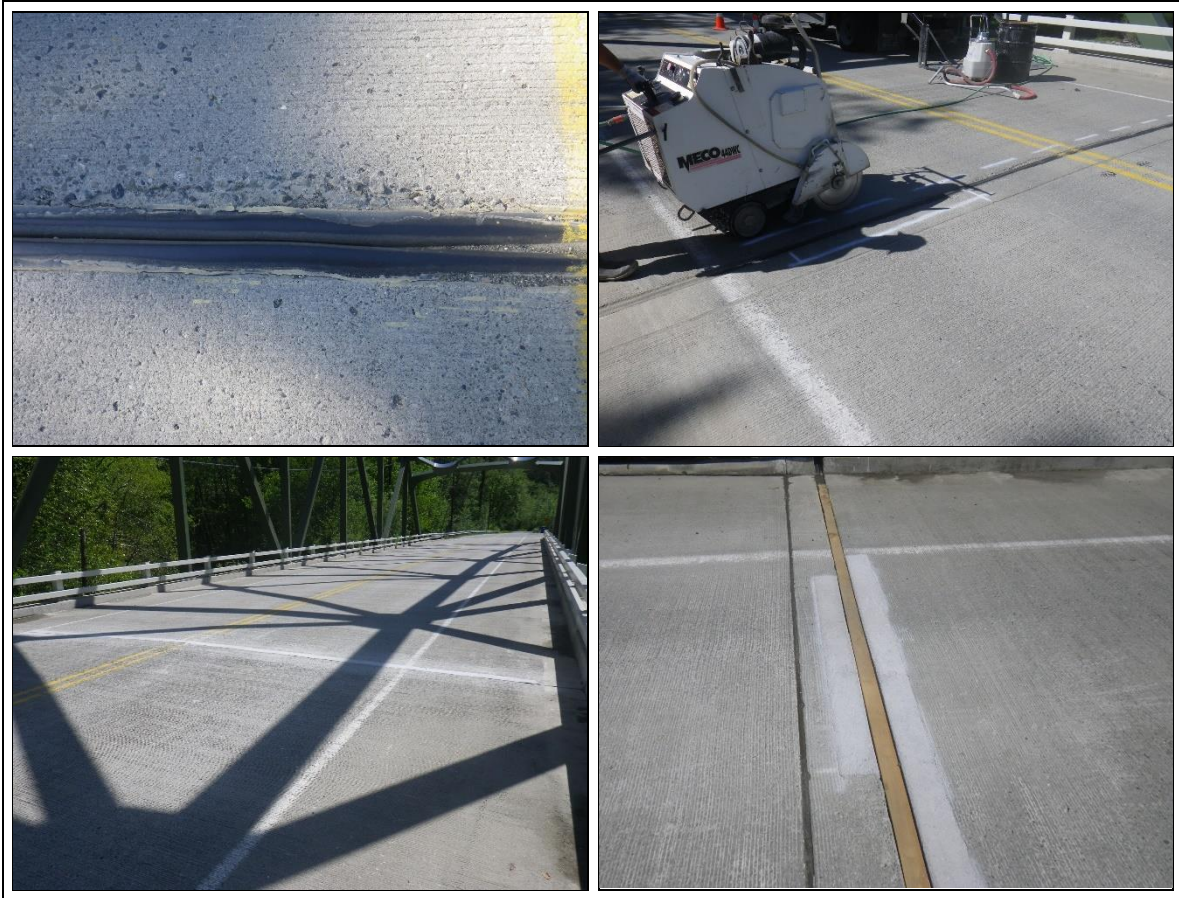
**Installation Notes:** Full span of deteriorated joint nosing on bridge over the South Fork Snoqualmie River was saw cut, demolished and replaced with Phoscrete F1-HC. Joint nosing on control joint was also demolished and replaced with Phoscrete.

**Reinspection Notes:** 5 year inspection reveals expansion and control joints in excellent condition with no shrinkage, no cracking, and no delamination.

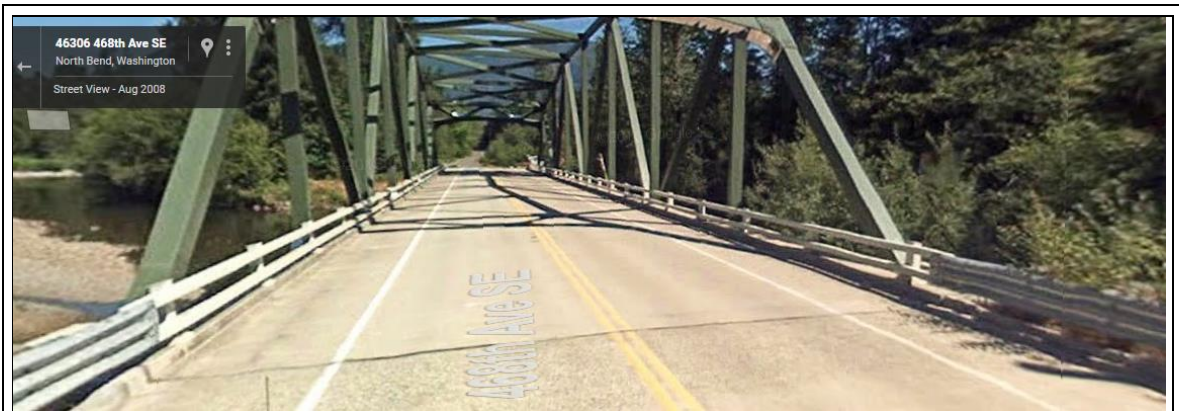
*Pre-installation view 08/ 2008 (Google Maps satellite image)*

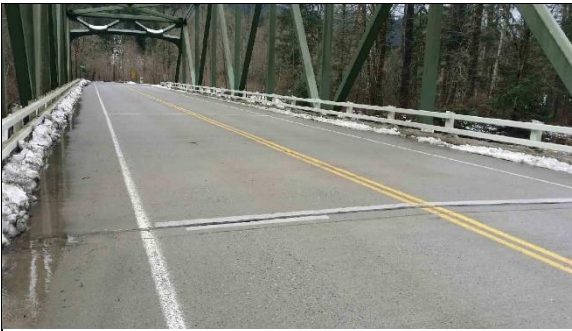
*5 year Inspection 2/11/2017*

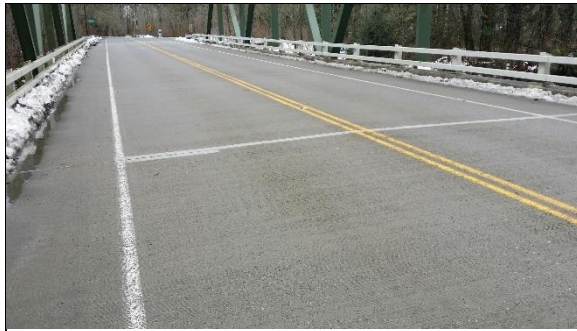
*5 year Inspection 2/11/2017*
