## CASE STUDY : PHOSCRETE F1-HC

### Bridge Expansion Joint Header

**Location:** [Burnside Bridge, Portland OR](#)

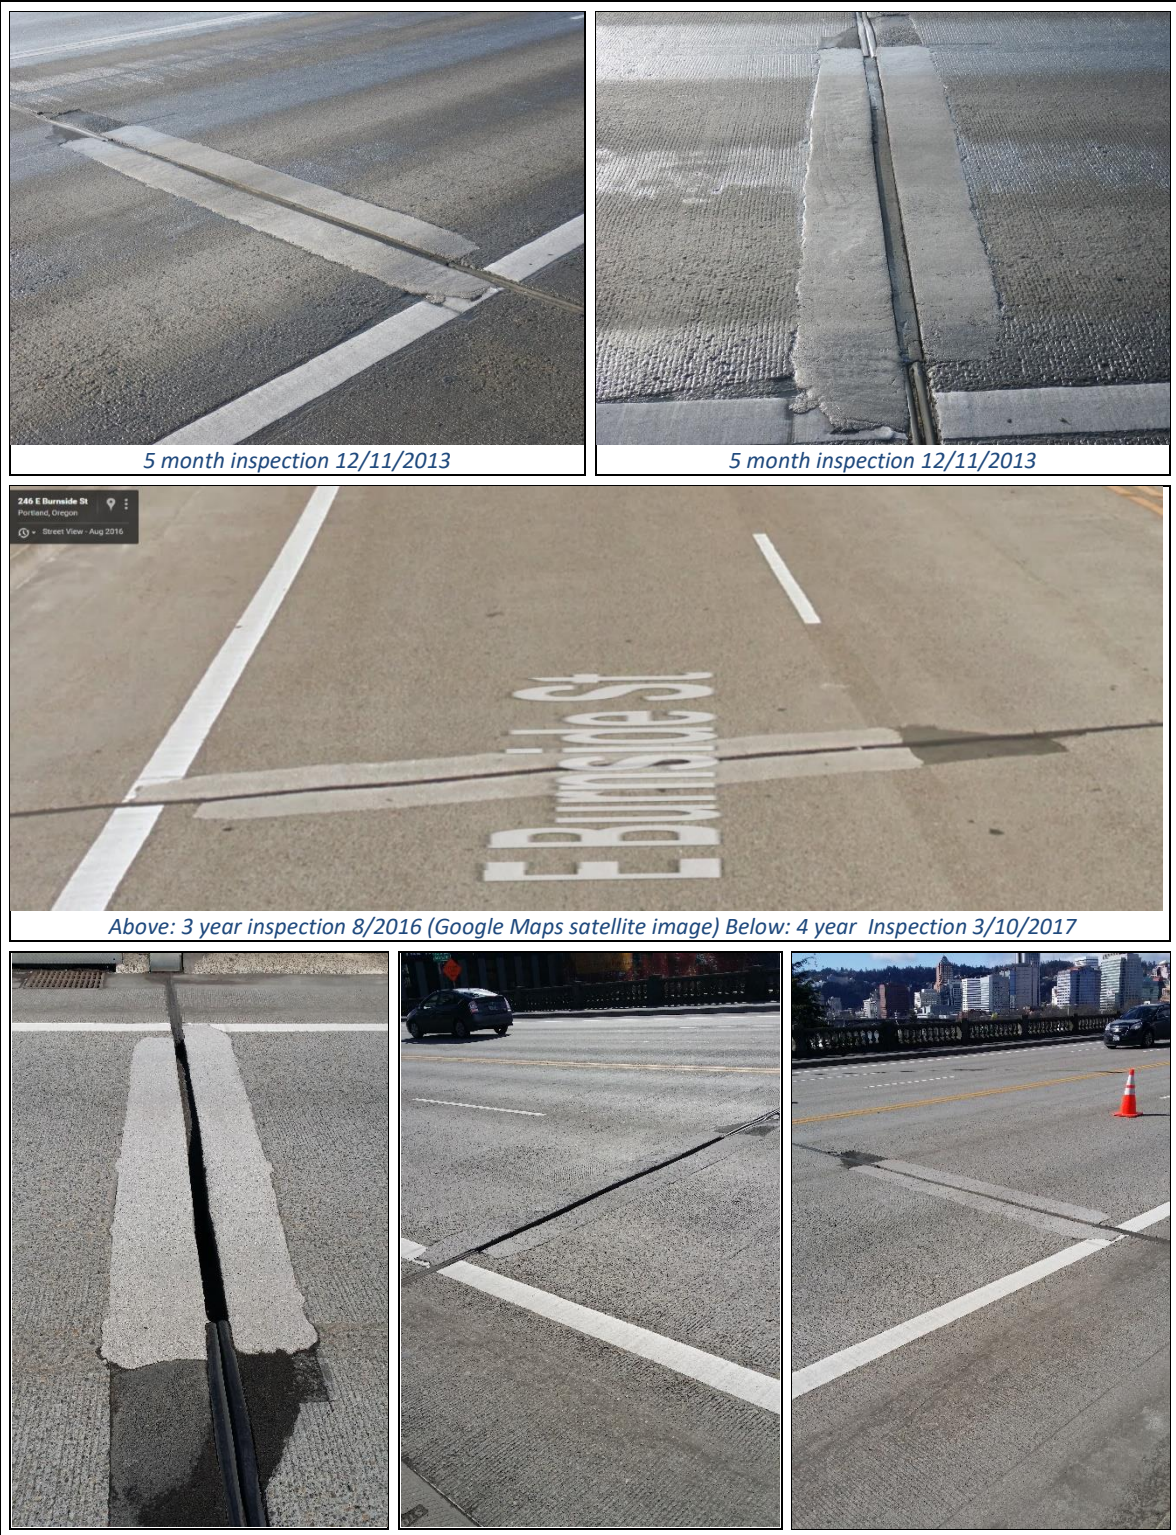
**Reinspection Notes:** Following five days of subfreezing temperatures, a five-month site reinspection showed no shrinkage, no cracking, and no delamination. Follow-up Inspection photos show the repair solidly in place after 4 years.
