CASE STUDY : PHOSCRETE F1-HC

Bridge Expansion Joint Header

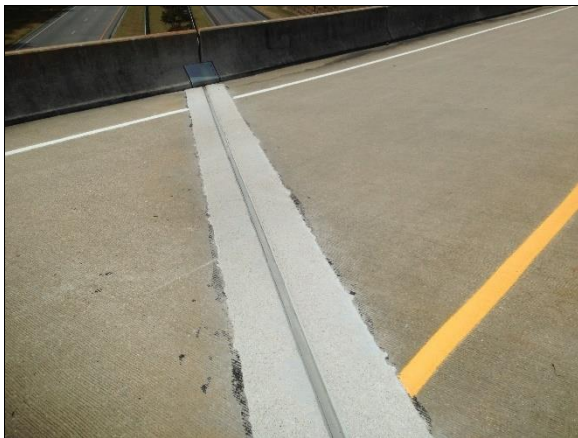
6 month Inspection 9/18/2013

Reinspection Notes: Phoscrete repair shows some hairline cracks (less than .2mm) but zero debonding, delamination, or shrinkage. Elastomeric material showed extensive debonding and pitting. Additional photos can be viewed at this [Google Photos Link](#).
