## CASE STUDY : PHOSCRETE F1-HC

### Bridge Expansion Joint Headers

**Location:** [I-4 Sanford FL](#)

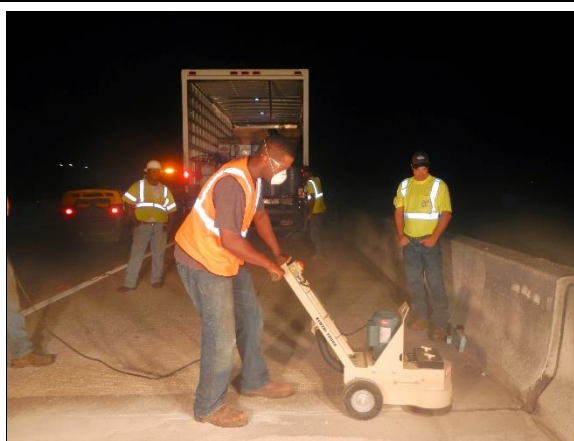
*Bump grind for rideability 15 minutes after set*

**Installation Notes:** Repairs were performed on 2 expansion joints on I-4 outside Orlando over two nights. Phoscrete was quickly installed, bump ground for rideability, and then the header face was angle-ground shortly after initial set. Silicone joint sealant was installed in the same night, same lane closure and highway open to traffic by 5AM.

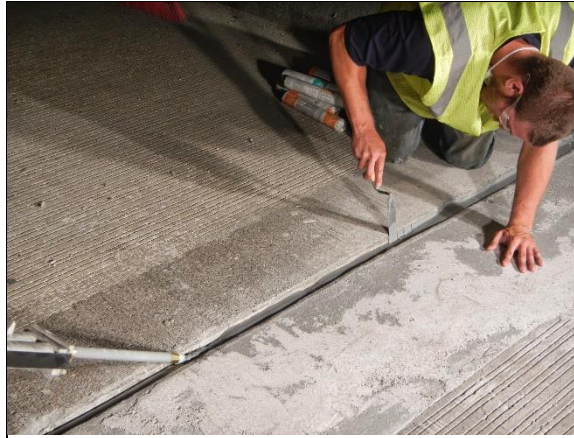
*Install silicone joint seal 1 hour after initial set*

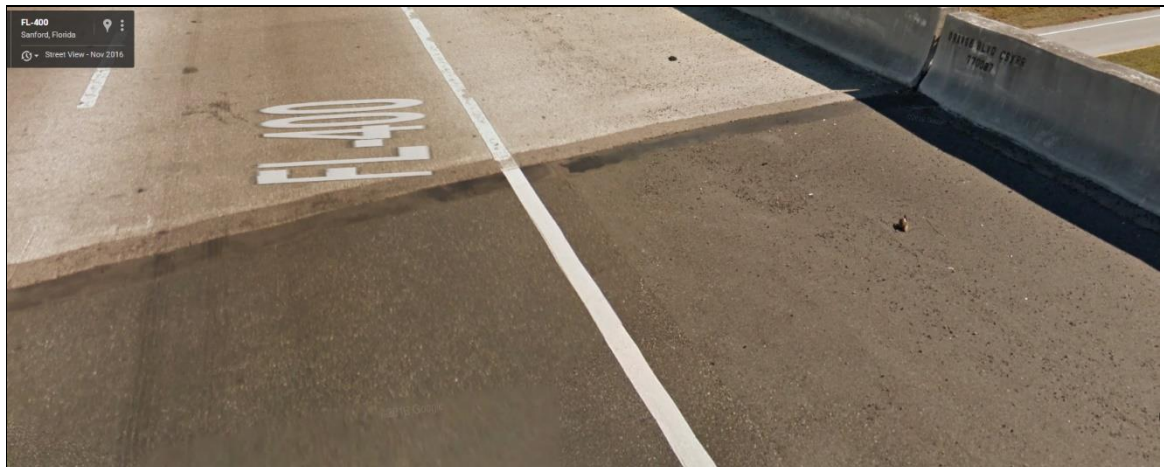
**Reinspection Notes:** Google Maps satellite photo of first expansion joint 30 months after installation. Bridge was treated with MMA, fully compatible with MALP Concretes.

*2.5 year inspection 11/ 2016 (Google Maps satellite image)*
