## CASE STUDY : PHOSCRETE F1-HC

### Form and Pour Spillway Repair

**Location:** [Folsom Dam, Folsom CA](#)

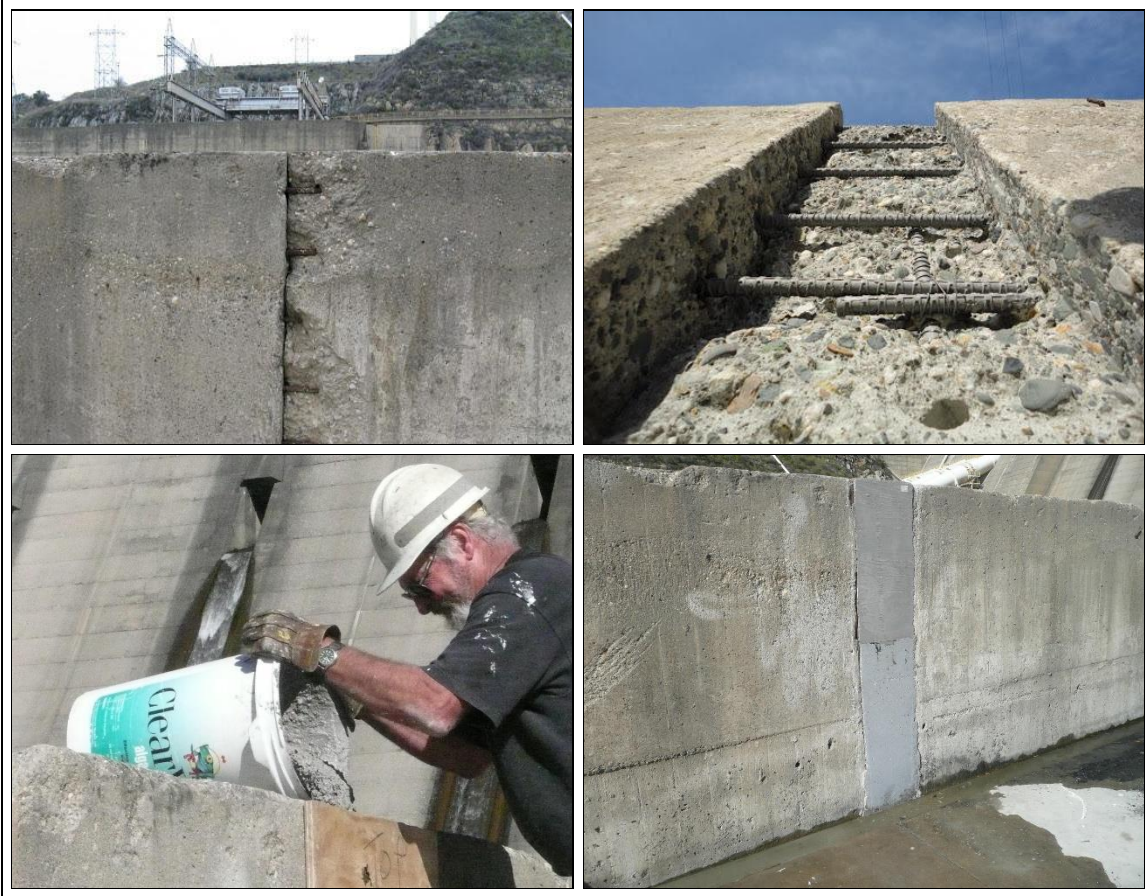
**Installation Notes:** Spillway wall was spalled. Damage concrete was removed by sawcut and chipping. Plywood forms were used to serve as a bond-breaker between the panels and also to form up the repair. Phoscrete was cast-in-place and the forms were removed after 30 minutes.

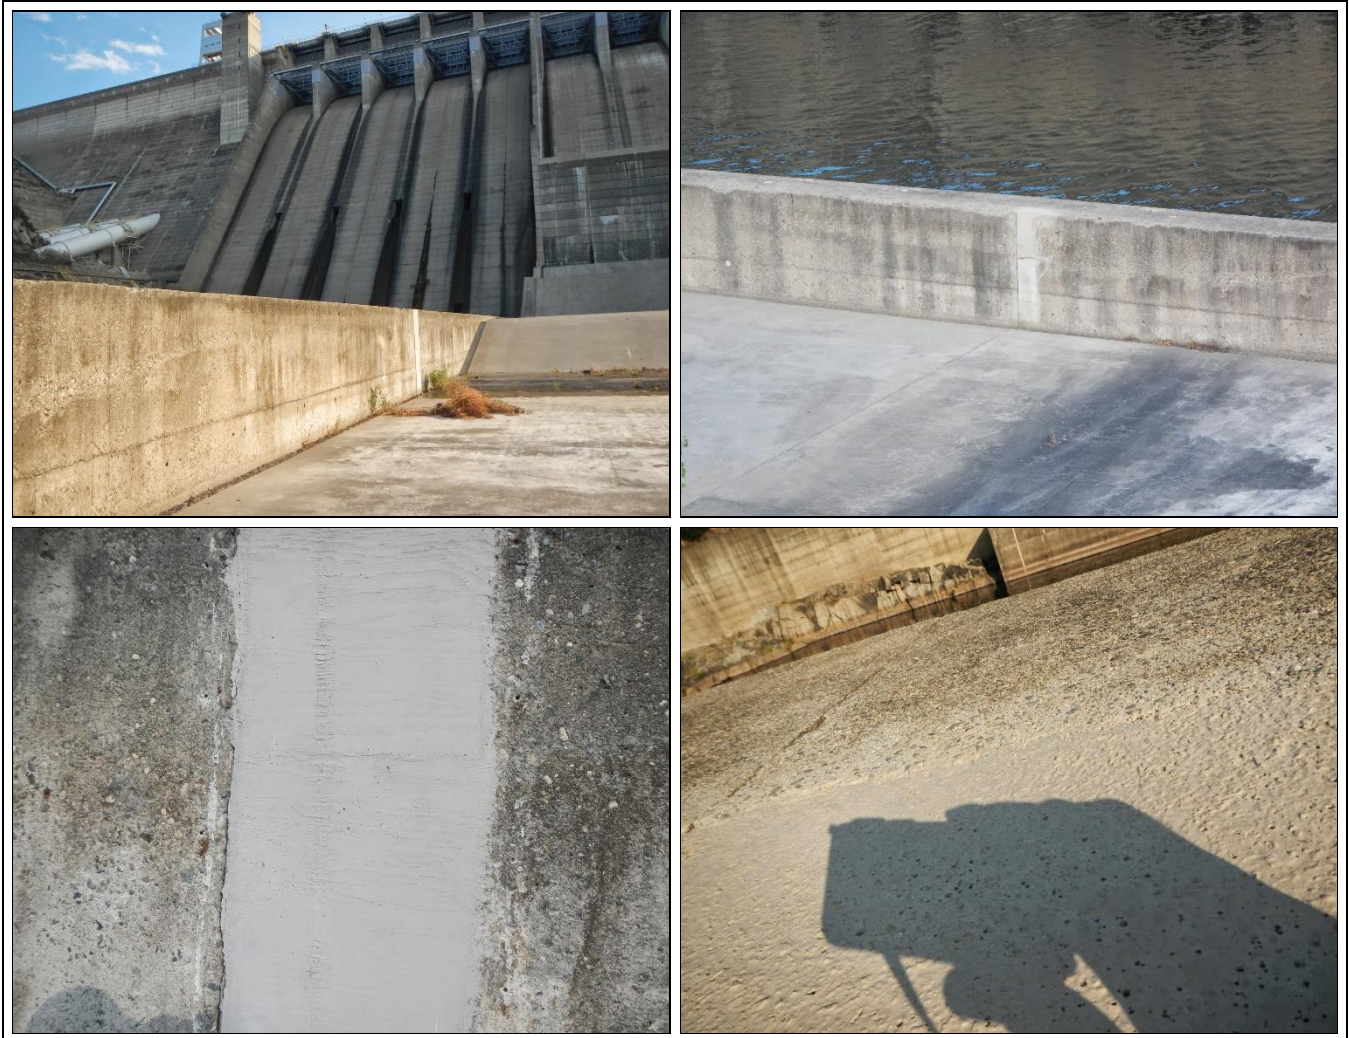
**Reinspection:** 29 July 2014 Phoscrete repair was solid in place with no shrinkage, no cracking and no delamination. Last photo is a view from the top of the repair. Additional Phoscrete material was purchased and installed by USBR maintenance personnel for various vertical and horizontal repairs on the Folsom Dam premises.
