CASE STUDY : PHOSCRETE F1-VO

Bridge Beam Repair

Location: [CA-70 Bridge, Oroville, CA](#)

Installation Date: 03 November 2016

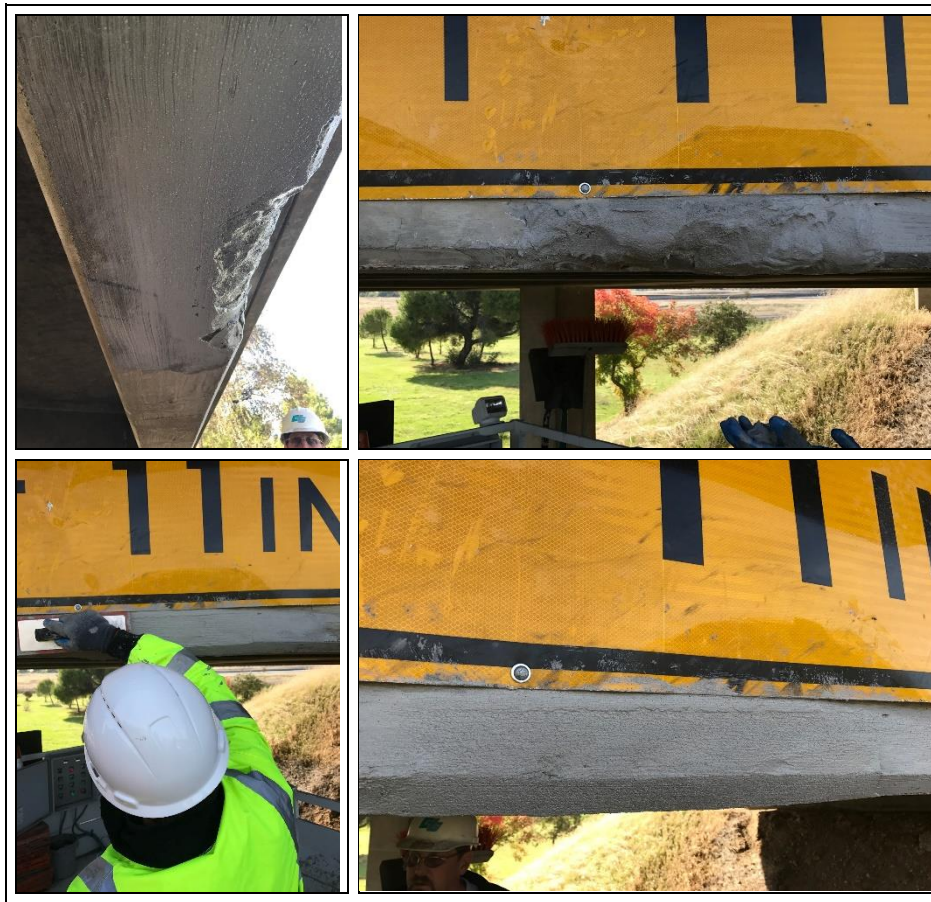
Installation Notes: Bridge beam was damaged by a vehicle. Site was prepared and cleaned. Phoscrete was installed first with a scrub coat, then in lifts. Using standard tools and water as a bond breaker, the repair was quickly smoothed and finished.
