## CASE STUDY : PHOSCRETE F1-VO

### Multiple Vertical Patches

**Location:** [Folsom Dam, Folsom CA](#)

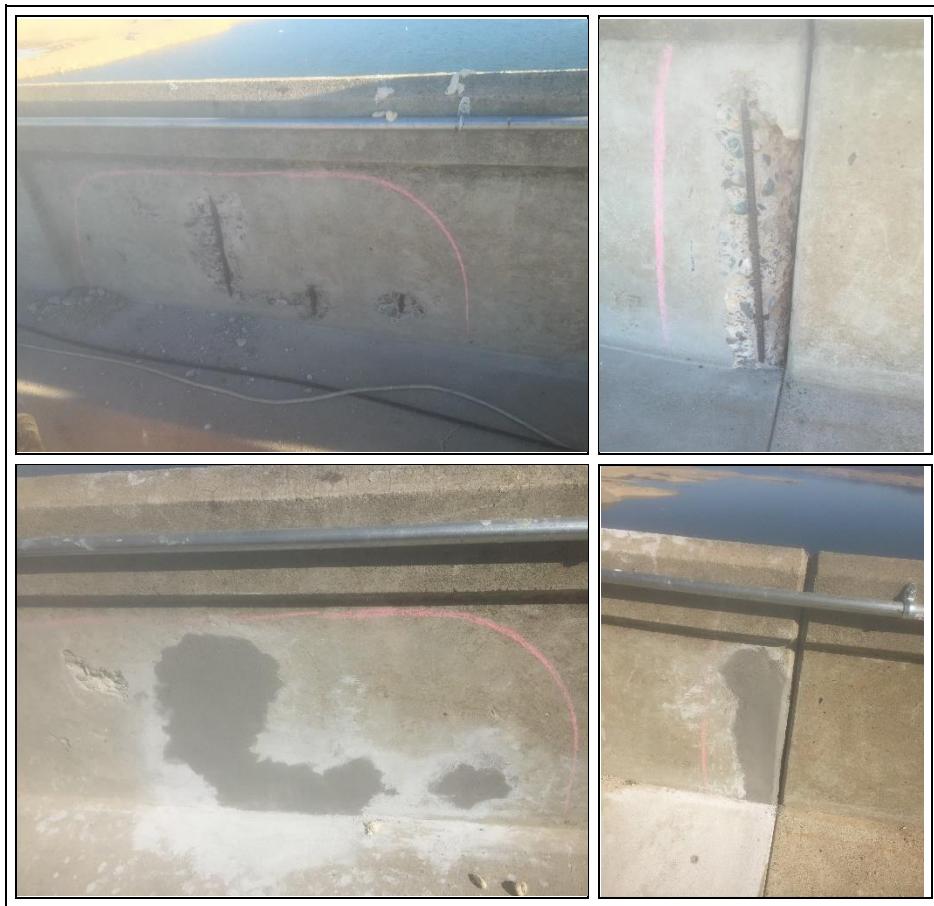
**Installation Notes:** Multiple instances of spalled concrete on site, many caused by corrosion of reinforcing steel. Damaged and weak concrete was removed using a circular saw and a pick axe. Phoscrete F1-VO was hand packed and trowel finished onto the repairs.
