## CASE STUDY : PHOSCRETE VO

### Large Overhead Patch - Bridge

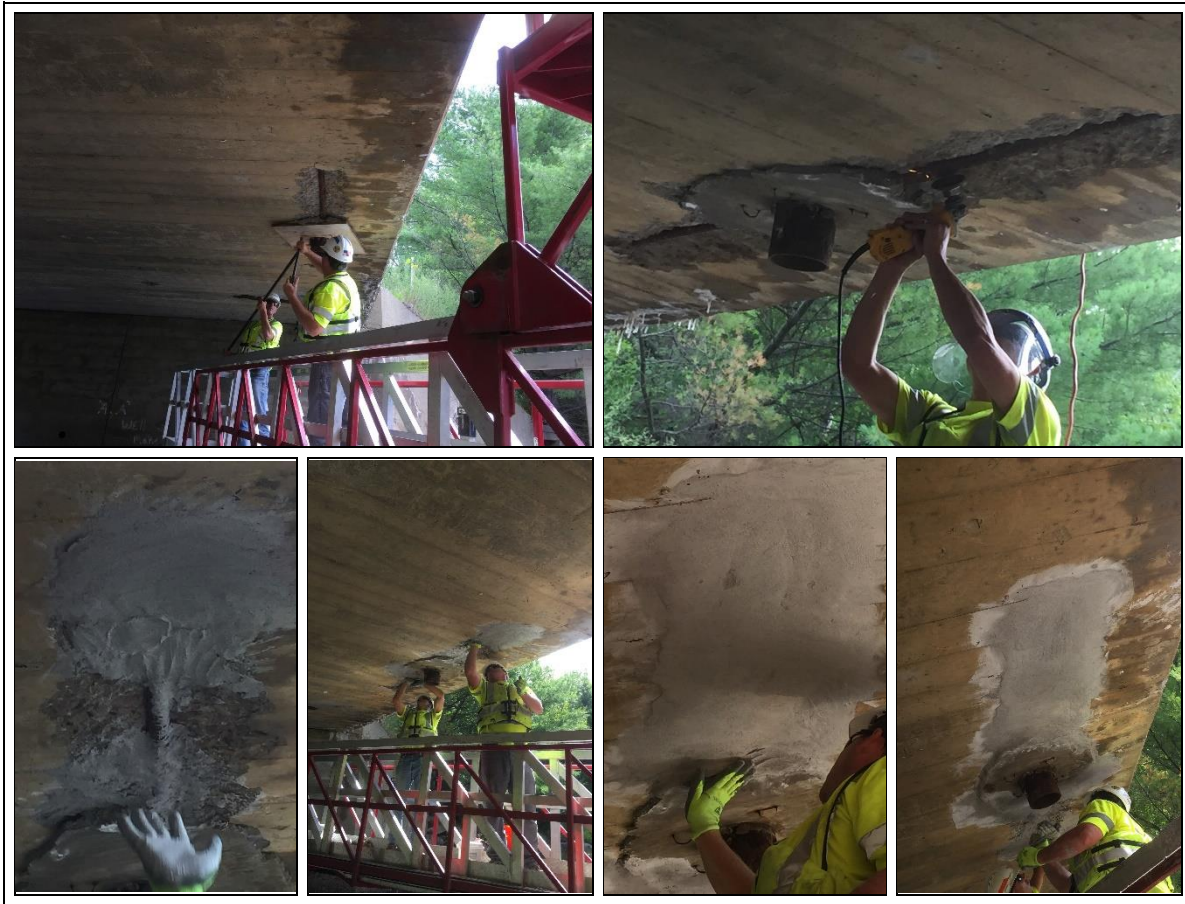
**Installation Notes:** UBIT required to access spall on overhead of bridge. Damaged concrete removed exposing corroded rebar. Shotblasting was not required per Phoscrete Performance Specifications. Phoscrete VO mixed on-site, then hand packed and trowed finished. Entire repair was completed in 2 hours.
