## CASE STUDY : PHOSCRETE HC

### Bridge Joint Header Repair

**Installation Notes:** Full span of deteriorated joint nosing on bridge over the South Fork Snoqualmie River was saw cut, demolished and replaced with Phoscrete HC. Joint nosing on control joint was also demolished and replaced with Phoscrete.

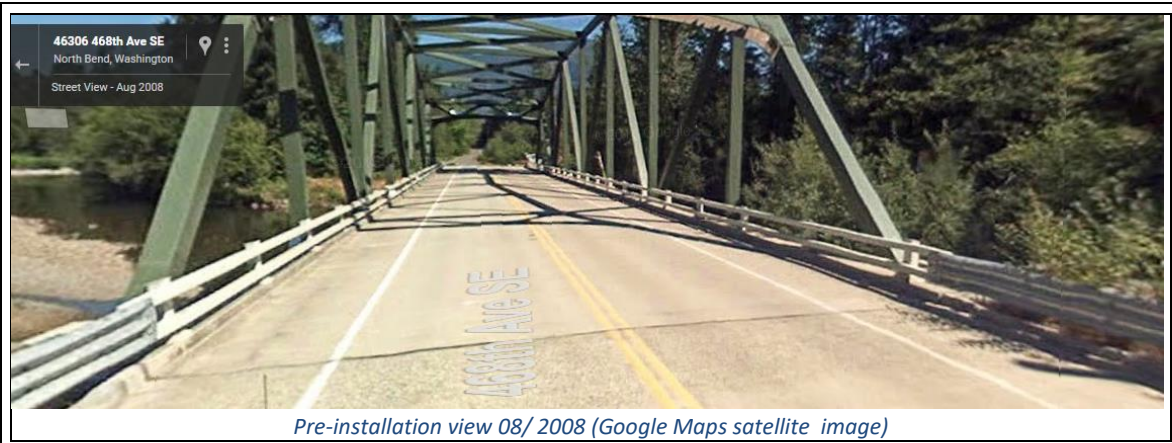
*5 year Inspection 2/11/2017*

**Reinspection Notes:** 5 year inspection reveals expansion and control joints in excellent condition with no shrinkage, no cracking, and no delamination.
