CASE STUDY : PHOSCRETE VO

Multiple Vertical Patches

Location: [Folsom Dam, Folsom CA](#)

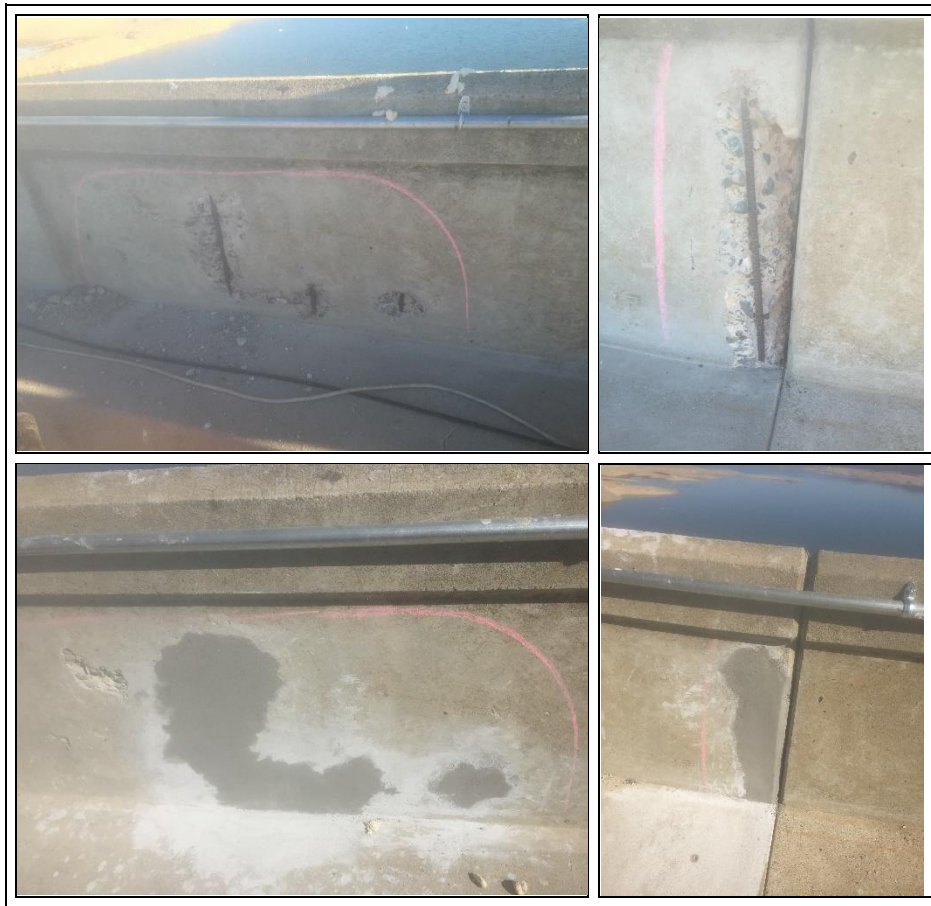
Installation Notes: Multiple instances of spalled concrete on site, many caused by corrosion of reinforcing steel. Damaged and weak concrete was removed using a circular saw and a pick axe. Phoscrete VO was hand packed and trowel finished onto the repairs.
