CASE STUDY : PHOSCRETE HC

Bridge Joint Header Installation

Location: [Clyde NC](#)

Agency: NCDOT (GLF Construction Corporation)

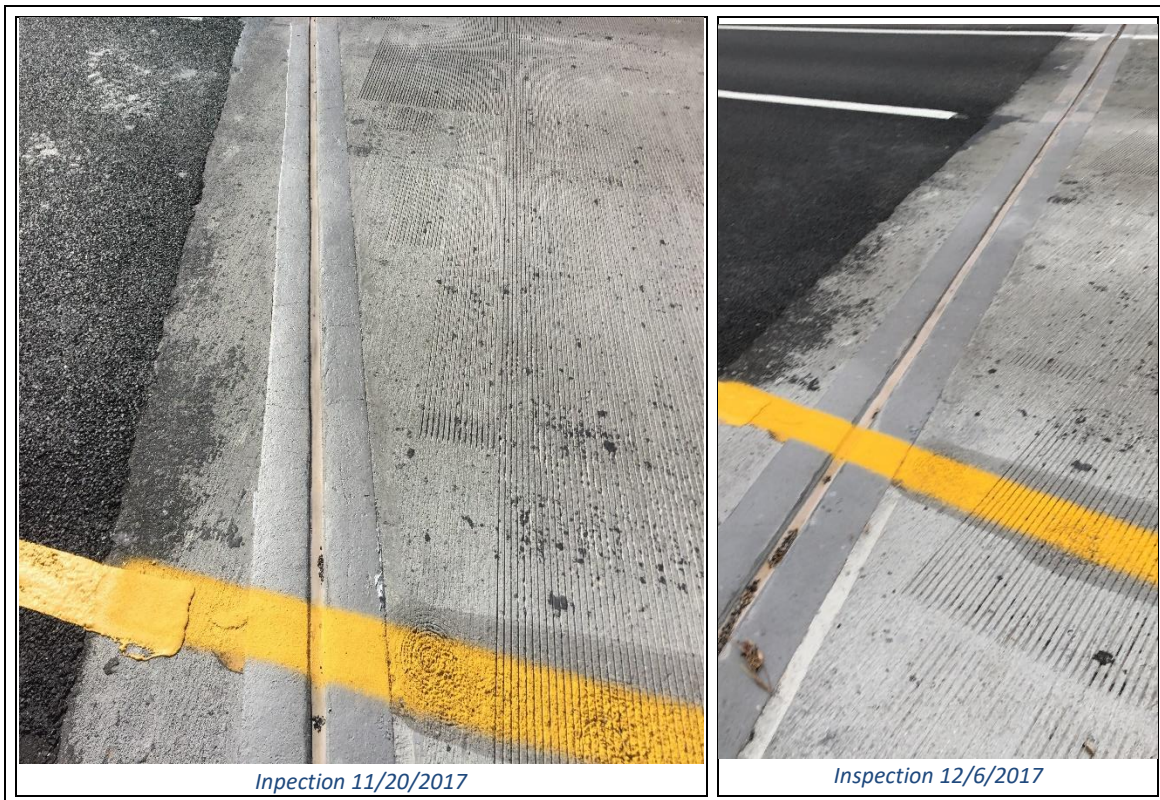
Because of the close attention paid to this repair, the header was inspected on November 20, 2017, December 6, 2017, and February 18, 2018. Hairline cracks were observed in the header in November. This is normal and likely attributed to impact/load stress from heavy truck traffic. No additional hairline cracks were observed in subsequent inspections, and the size did not change. Hammer testing indicates no delamination across the joint. no spalling was observed.

Cameron Cochran, NCDOT Western Regional Bridge Construction Engineer and the contractor GLF agreed to demolish and re-install the header using Phoscrete HC with Phoscrete's installation manager, Don Visel on-site for training and support.
